Pyramid of Khufu: two entrances and closing the King's Chamber, in the words of Jean-Pierre Houdin

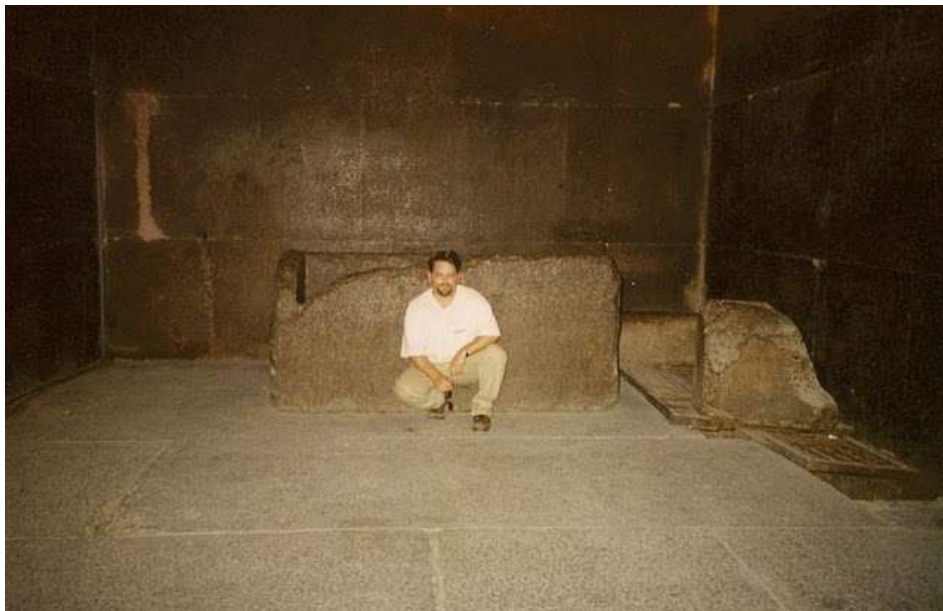
Where is the block, to the right of the sarcophagus, gone? (Photo Keith Payne)

First observation made by Jean-Pierre Houdin: where did the stone block come from that we could still see, a few years ago, beside the sarcophagus, on the west side of the north wall of the King's Chamber? And what happened to it, since it has now disappeared?

The answer to the second part of the question is simple: during renovation of the King's Chamber in 1998, Dr Zahi Hawass, then supervisor in charge of Egyptian antiquities, ordered the block to be removed. No doubt he thought it was too untidy.

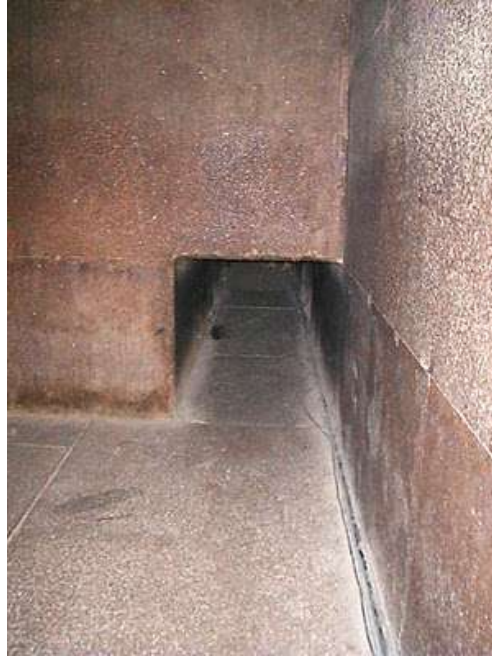
**Entrance in the northeastern side of the King Chamber**

The block's dimensions, observes Jean-Pierre Houdin, exactly matched (since it has disappeared, we should use the past tense) those of the entrance in the east of the funeral chamber's north wall. So it quite naturally had its place, as originally planned.

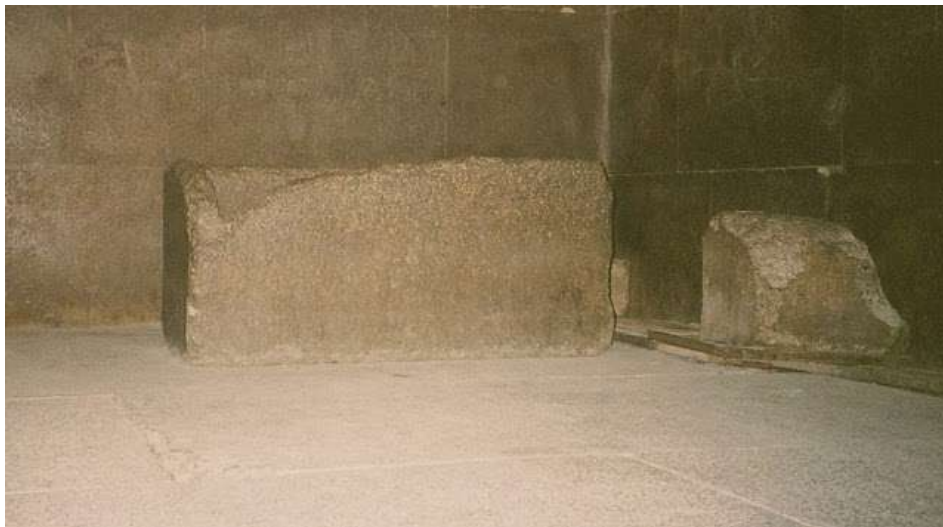
**“The block rests on the face which was the one visible from the King Chamber. It went on this face when the robbers broke into the room. Once set upright, it would be close to the sarcophagus height, less the part which was smashed by the robbers to get enough clearance to tip it over. On the far right, the most damaged part should be the upper part; on the left, its base; in the center, the west face of the block”.**

We should immediately note that there is a difference of 2 cm between the floor levels in the chamber and in the corridor, the latter being lower. We must also be aware that the cross-sectional area of the corridor between the Grand Gallery and the portcullis chamber is smaller than that of the corridor between the portcullis chamber and the King's Chamber. So for Jean-Pierre Houdin, the conclusion is clear: *"The block that sealed the entrance to the King's Chamber, on the east side, never passed through the portcullis chamber. And yet, it finished by exactly blocking access along the line of the north wall of the King's Chamber, pushed up against the floor in this room. For this reason, thieves who succeeded in reaching the back of this block via the entrance dug in the north face of the pyramid, the ascending corridor, then the Grand Gallery and finally through the portcullis chamber, were forced to break the top part of it and, when there was enough room, to tip it into the King's Chamber, where it loitered for 1,250 years."*

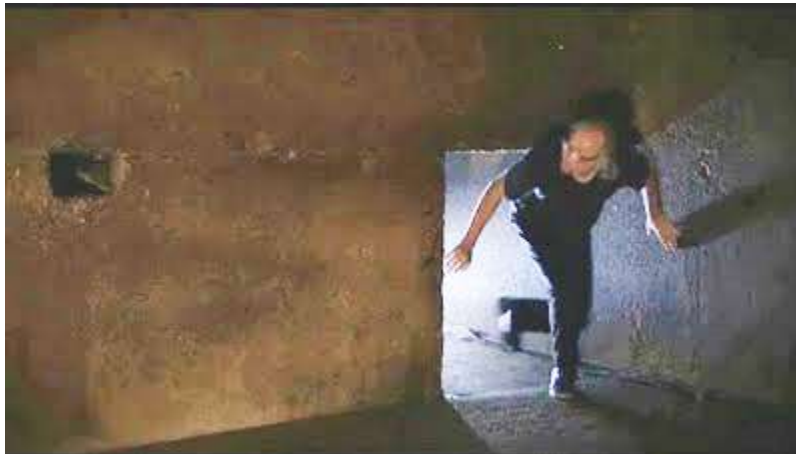
**“Northeastern entrance: to bow one's head”**

In other words, this block, whose function was to block the north-east entrance to the King's Chamber, was not put in place “after” the royal funeral ceremony. *“It was from the 17th year of the pyramid's construction, a date mentioned by graffiti in the last ‘relieving chamber’,”* explains Jean-Pierre Houdin, *“so when construction of the King's Chamber was finished and the counterweight system in the Grand Gallery no longer served any purpose, that, pushed from the inside of the chamber before the setting in place of the slab on which it stopped, it was put into the place it occupied until the year 850 AD (arrival of Al-Ma'mun), to seal access to the chamber. It was thus sealed for 3,350 years, no more, no less, until the day Al-Ma'mun's advance scouts broke it and then tipped it into the chamber. But it was then no longer in its original position.”*

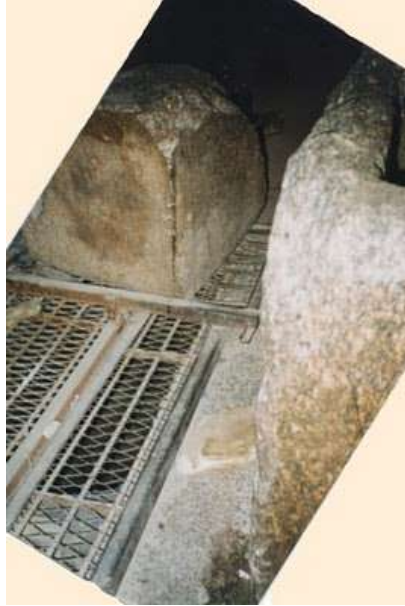
Al-Ma'moun sapping

It becomes a question of the sapping, on the west side of the north wall of the King’s Chamber. It has a quite unusual history.

Why did Al-Ma'mun’s soldier-engineers dig here precisely? They must certainly have spotted clues “somewhere” in the wall, attracting their curiosity and justifying their efforts.

These clues, if they were really revealing, should still exist today. Al-Ma'mun, doubtlessly searching for any treasure associated with the funeral chamber, simply made a mistake in interpreting them. He had excavations made downwards, when he should have dug horizontally!

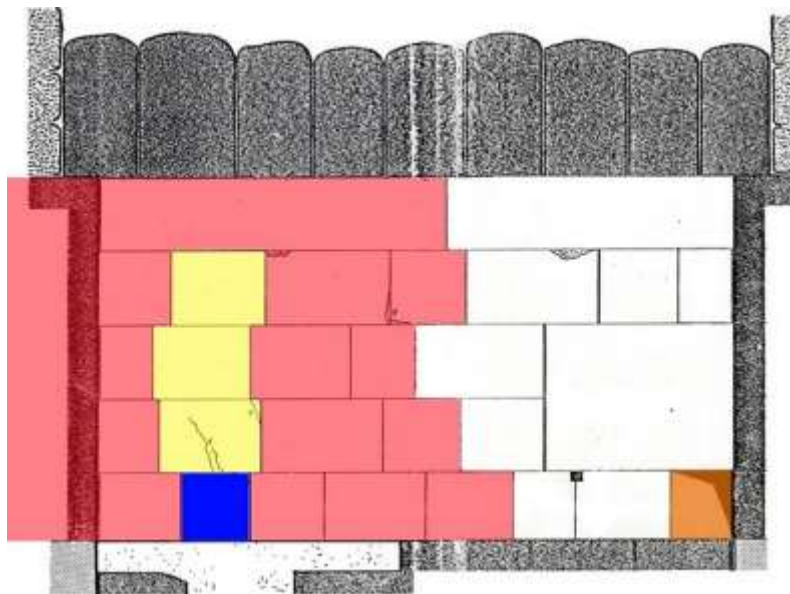
From Gilles Dormion drawings

So let's look at the north wall, following Jean-Pierre Houdin's instructions: "What do we see on the wall? On the right (east side, low down, in orange), the entrance through which we currently enter this room. On the left, the layout of granite blocks forms a doorway (in pink) that takes the entire weight of the (dark) granite ceiling beams. The (yellow) blocks filling the doorway do not bear on the central block at the bottom (blue). This seals the second entrance. It is free, exactly like the block that once sealed the first entrance. Free: in other words, it could be moved... for example, at the end of the king's funeral ceremony, when the pyramid had to be sealed.

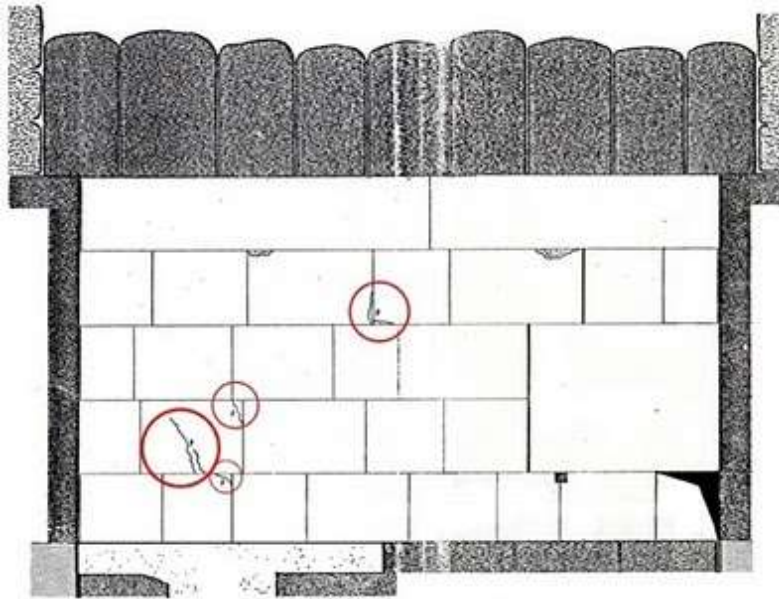
The cracks on the North wall of the King's Chamber (from Gilles Dormion drawings)

"Since these observations, I have entered the pyramid numerous times, especially to the King's Chamber, to make a close analysis of this north wall. I then paid attention to several other details. The first yellow block above the blue block is cracked in two places, at the center. This proves that there was a space between the two blocks, so that the one above did not rest on the one below. Furthermore, we know that the ceiling beams have been cracked since construction, following subsidence of the chamber's south wall. Later, certainly when Al-Ma'mouns workers dug the hole at the foot of the second entrance, the north wall also moved a little, 2 or 3 mm, i.e. practically nothing. But this was enough for the yellow block to crack and rest on the blue block.

"I also carried out an experiment with an out-of-date plastic credit card: I tried to slide it into the right-hand joint between the blue block and the pink block of the doorway. I could do it easily, although it is practically impossible elsewhere. (It is often said of the joints in the pyramid that they are so perfect you could not insert a razor blade into them.) I slid this card, laid flat, along the stones, from block to block, to check their alignment. The only time my card stopped was exactly on this joint, proving that the blue block is slightly below the pink block. If the blue block had been put into position at the same time as the other blocks in the chamber, it would have been perfectly aligned with the others."

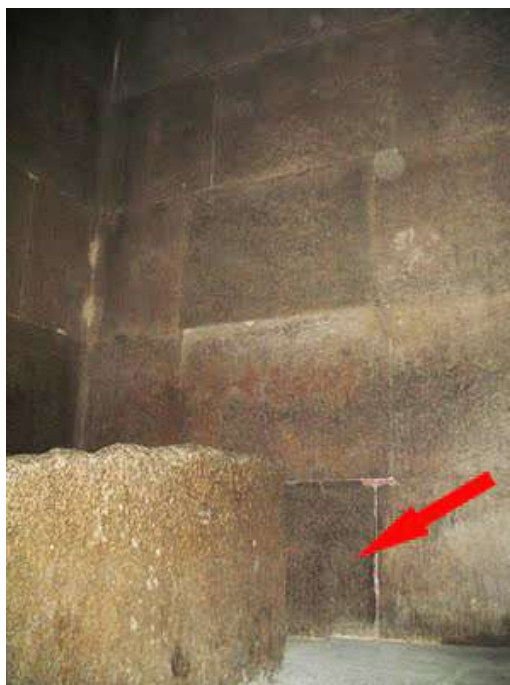
The true entrance in the King's Chamber

Passing (virtually) through the north wall of this room, from inside the King's Chamber, on the other side we actually find the upper part of the second antechamber, by passing along a fairly short corridor that plays an essential role in permanently sealing the funeral chamber, after the royal funeral.

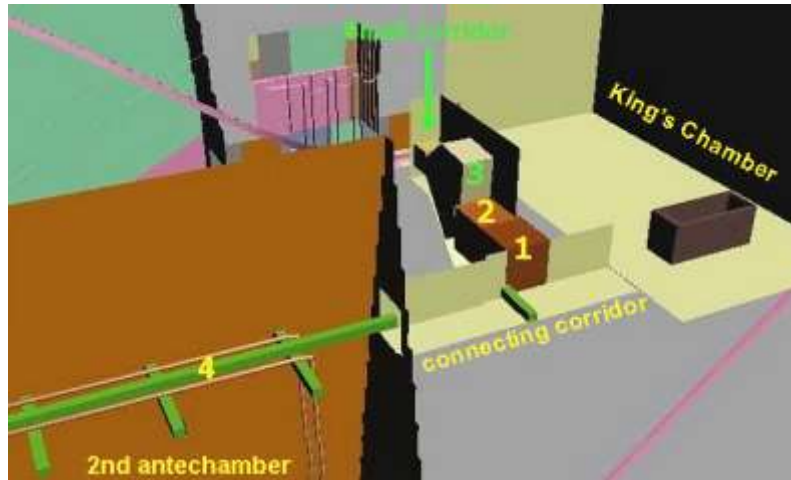
**Block N°1 in its initial position**

- 1 - Presence of a small corridor, about 4 cubits long and 2 wide, perpendicular to the connecting corridor and on its east side
- 2 - In this small corridor, two “twin” blocks (1 and 2 on the diagram above) were placed, the first becoming part of the east wall to the connecting corridor, the second “stuck” behind it.

- 3 - The front face of the second in contact with the rear face of the first was very slightly concave so as to leave a small space over the greater part of the surface. A brass “pad” was inserted into the second block, two thirds of the way up, projecting sufficiently to be theoretically in vertical alignment with the face. Its role was to allow the first block to be pushed fully into the corridor without “jamming” it against the opposite wall. When pushed by the piston (4 on the diagram), only this pad would be rubbed and very quickly worn away by the granite of the first block.

- 4 - As the driving force for the system, a pushing block (3 on the diagram), based on the type of drop-stone trap built into a corridor of the Bent Pyramid: this expertise gave rise to a pushing block used for the Red Pyramid and Khufu’s Pyramid.

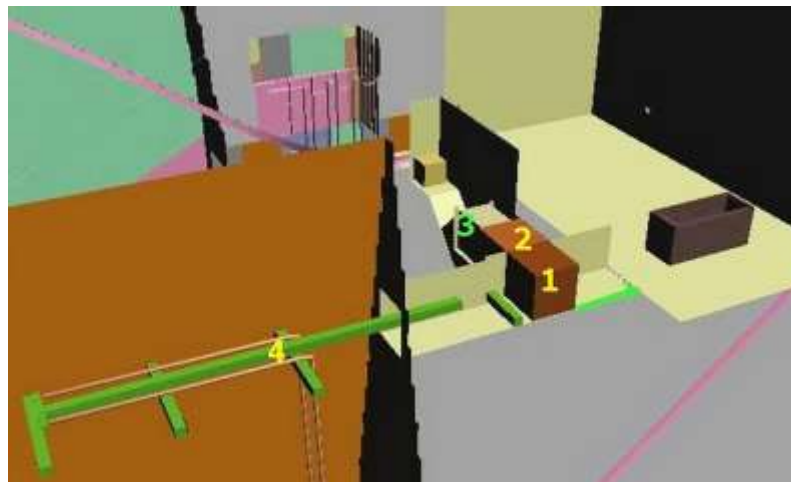
**During the sealing process: the piston (4) will push block N° 1**

- 7 - The piston was pre-assembled in the second antechamber, on cross-beams. It did not move as long as the first block had not been pushed into the connecting corridor.

- 8 - Once the block was in the corridor, the piston was moved up to its north rear face (formerly the north side face of the block when it was still in the perpendicular corridor), then placed against it.

- 9 - In order to get the 750Kg-f needed to move the block, eight workers climbed onto the traction ropes, and four others pulled on the assembly: the first block moved forward in the connecting corridor until it stopped against the raised edge of the King’s Chamber floor.
