Egypt Fourth Dynasty

# CRITICAL ANALYSIS OF THE GIZA PLATEAU

Study carried out by Jean-Pierre Houdin

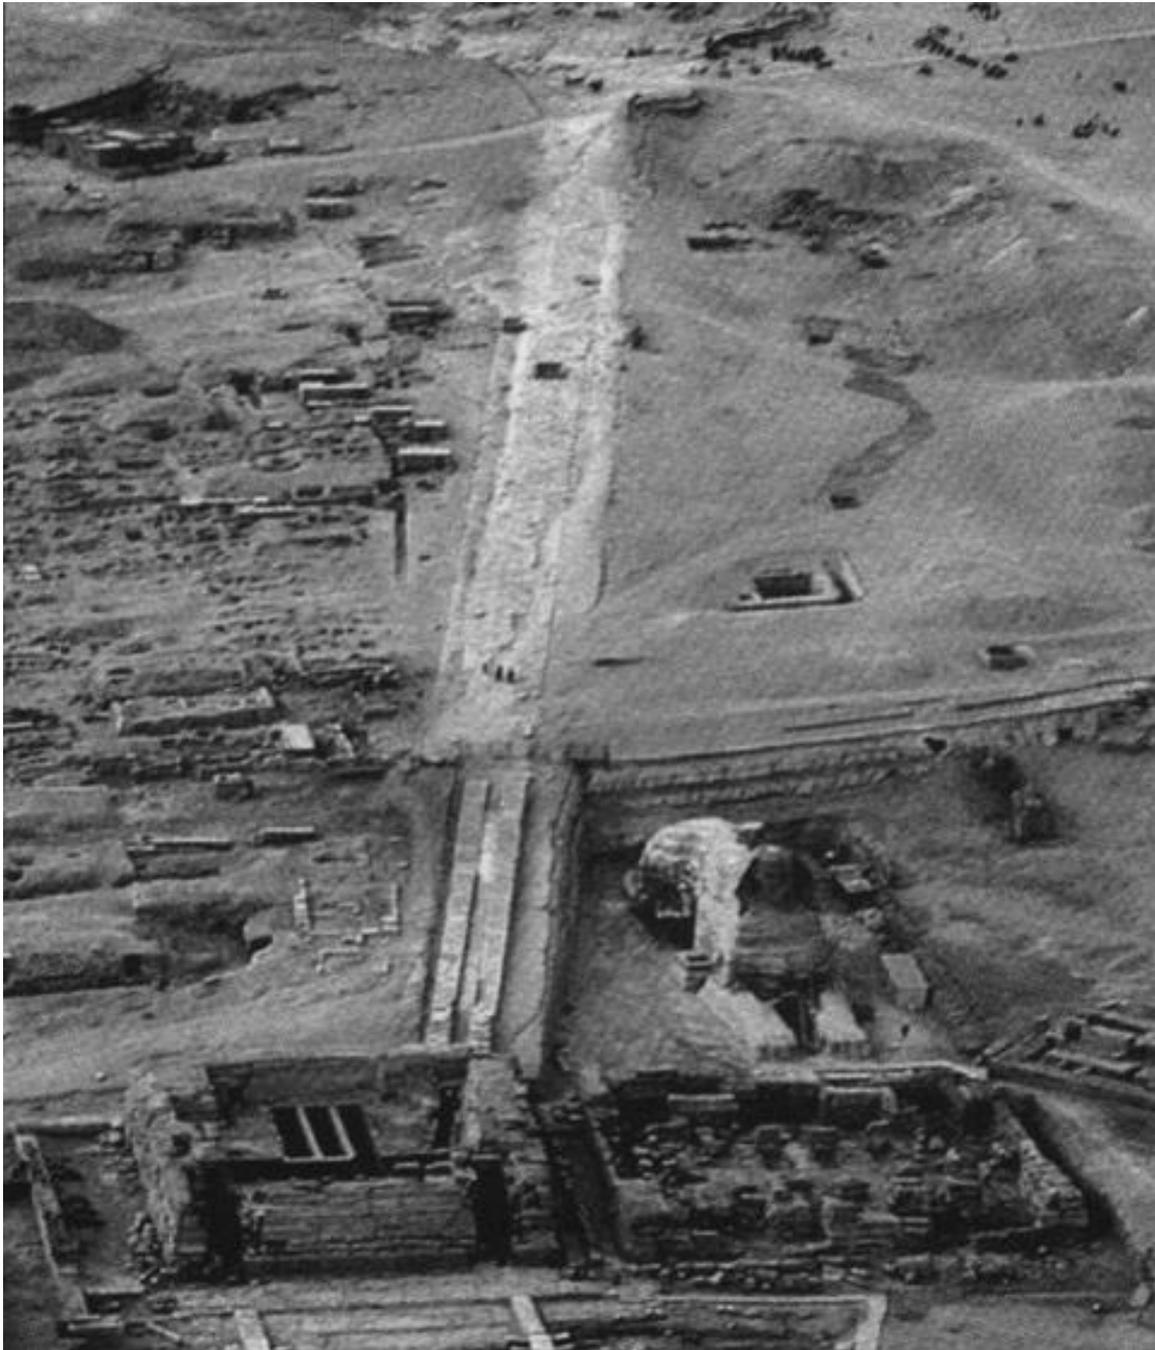
Centre: the Royal Causeway of Khafre (centre), the Sphinx in a half-filled quarry (right).

We can clearly see a ramp forming the foundations of the Royal Causeway of Khafre.

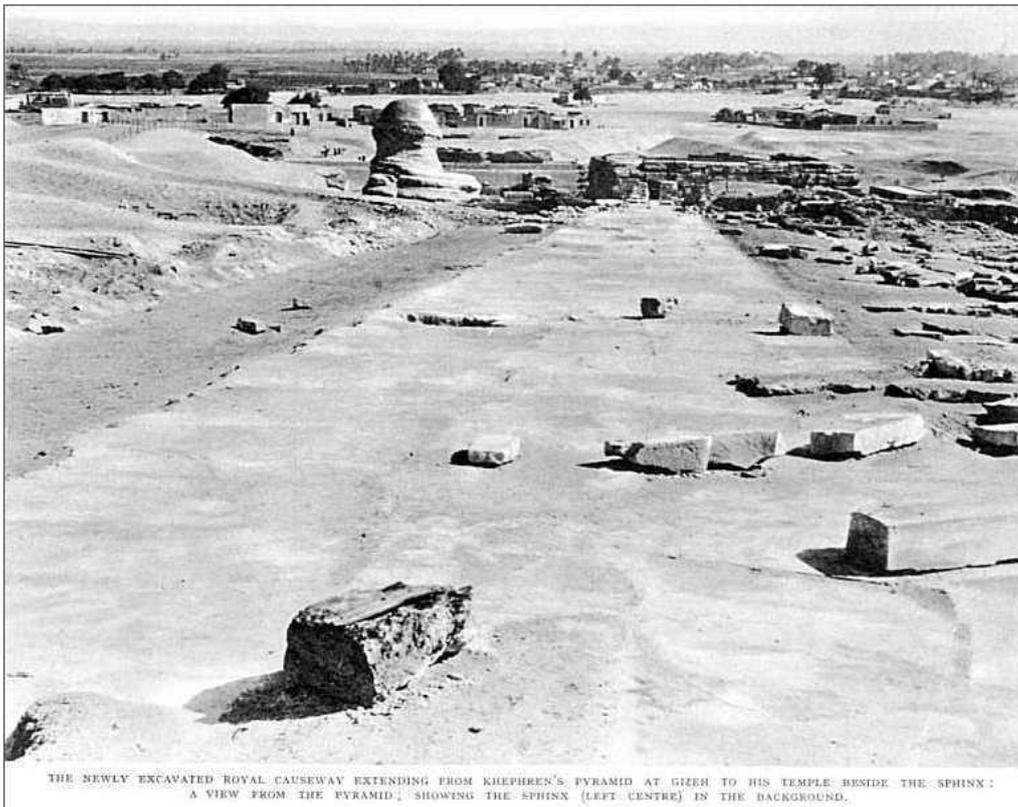
Old view towards the east of the Royal Causeway (photograph taken halfway along).

The foundations of the Royal Causeway are uniform across their entire width, which is much wider than the Royal Causeway itself. This ramp, currently nearly 500 m long with a slope of 8.5%, is ideal for using sleds, even more so for dragging large sled-loads of beams using rollers.

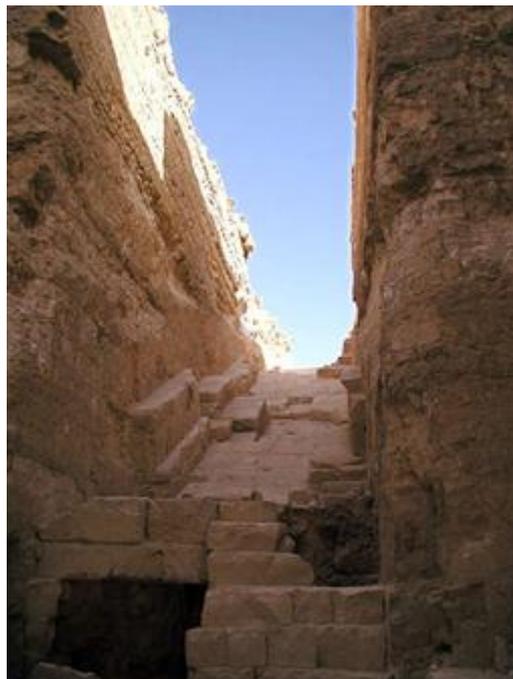
And the trench of the Pyramid of Djedefre at Abu Rawash.

This type of trench was therefore quite normal for the Egyptians.

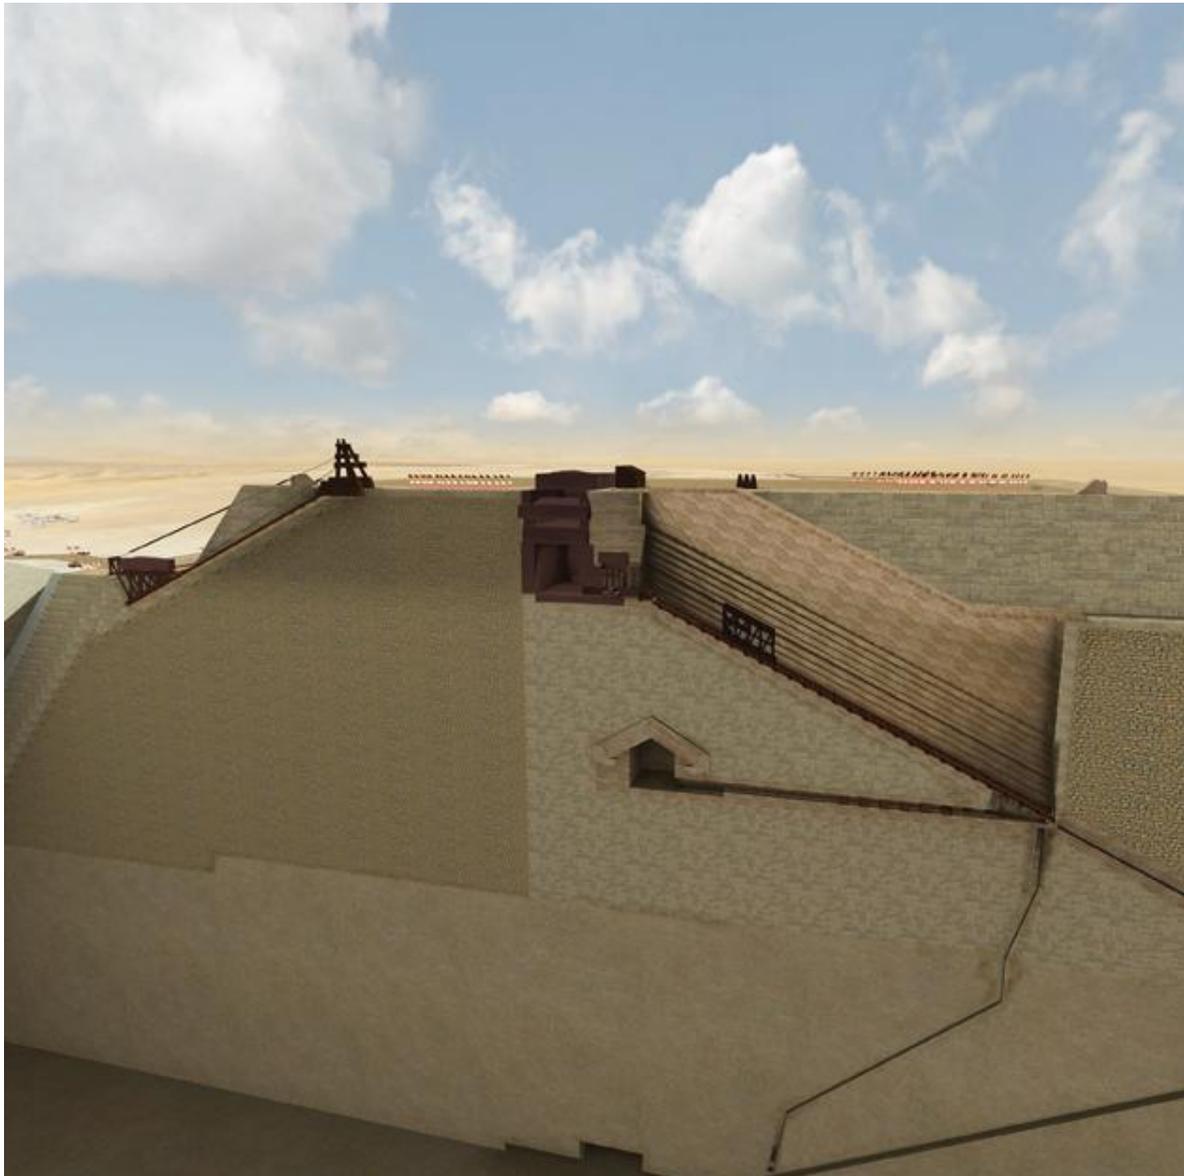
The counterweight system (on the right in this illustration), namely the platform for the beams, the set of rollers, lateral notched wooden bars, etc. as well as stones for the banks in this section, will be used first. Everything was used and reused as much as possible.

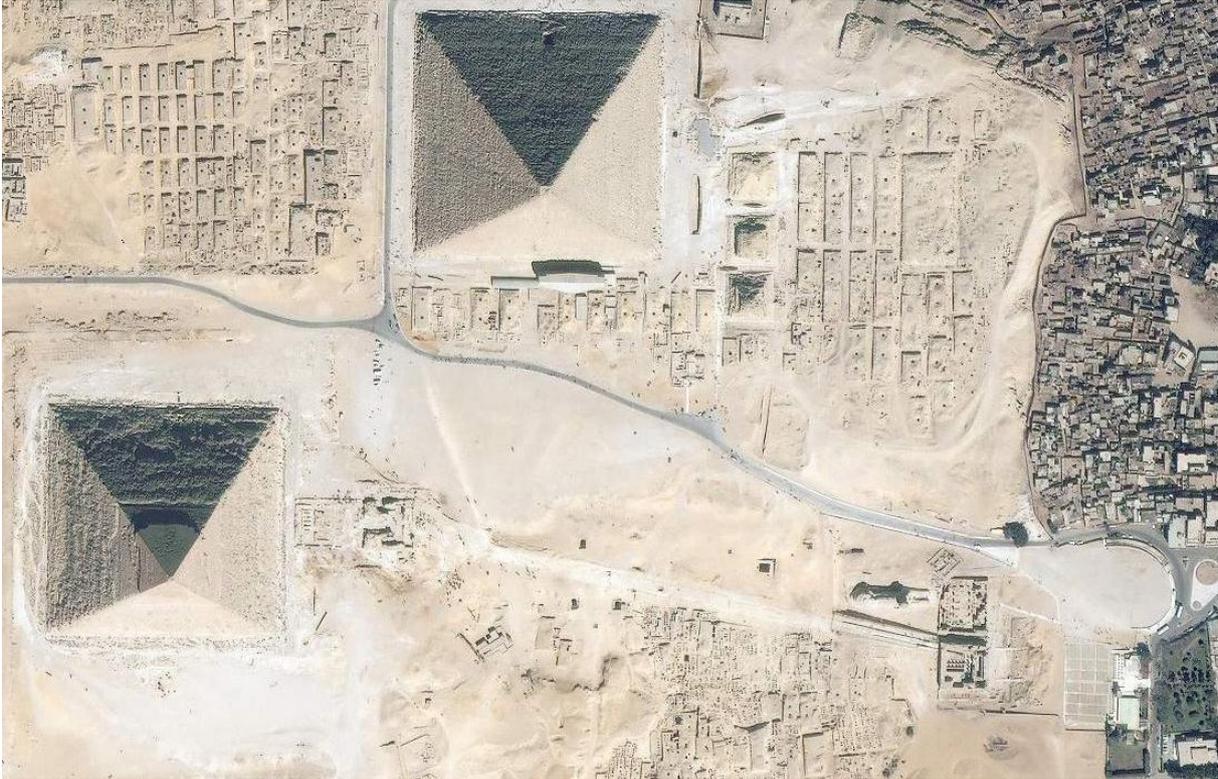
The “slideway” trench for the first counterweight must have been located along the axis of the Royal Causeway of Khafre.

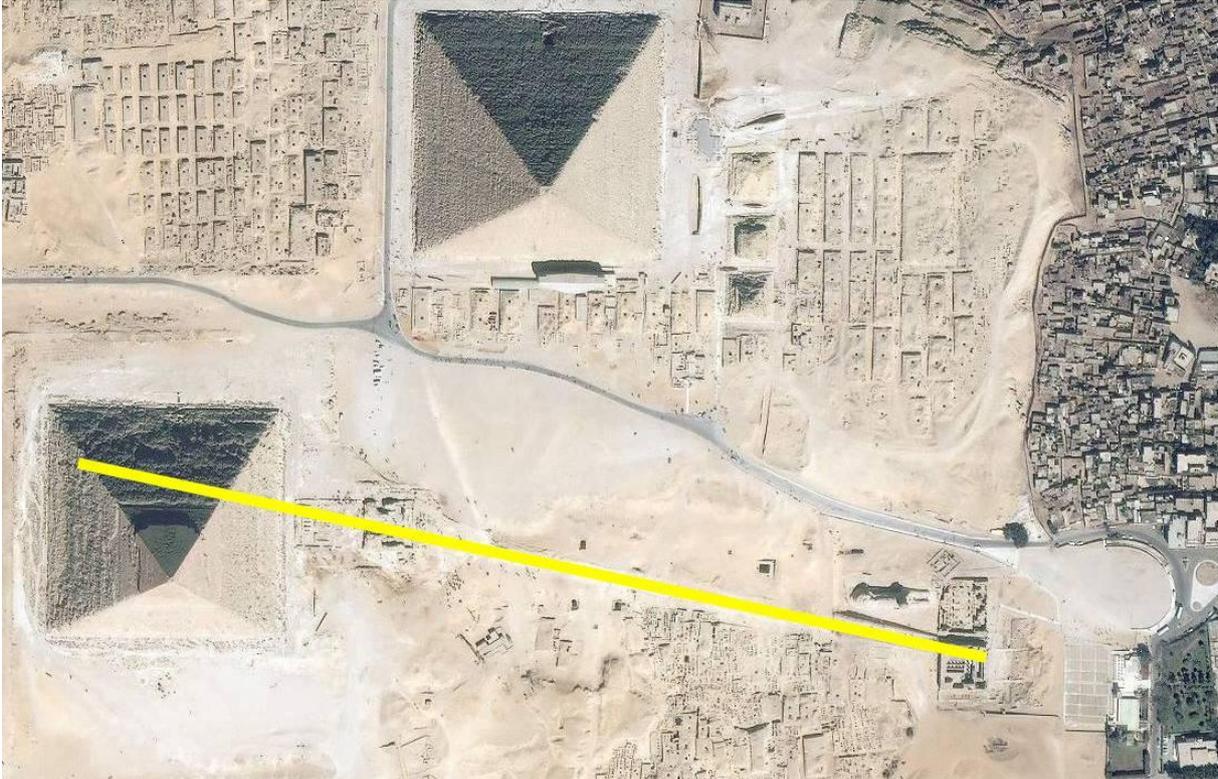
The axis of the exterior ramp of Khufu intersects the Royal Causeway by the High Temple of Khafre.

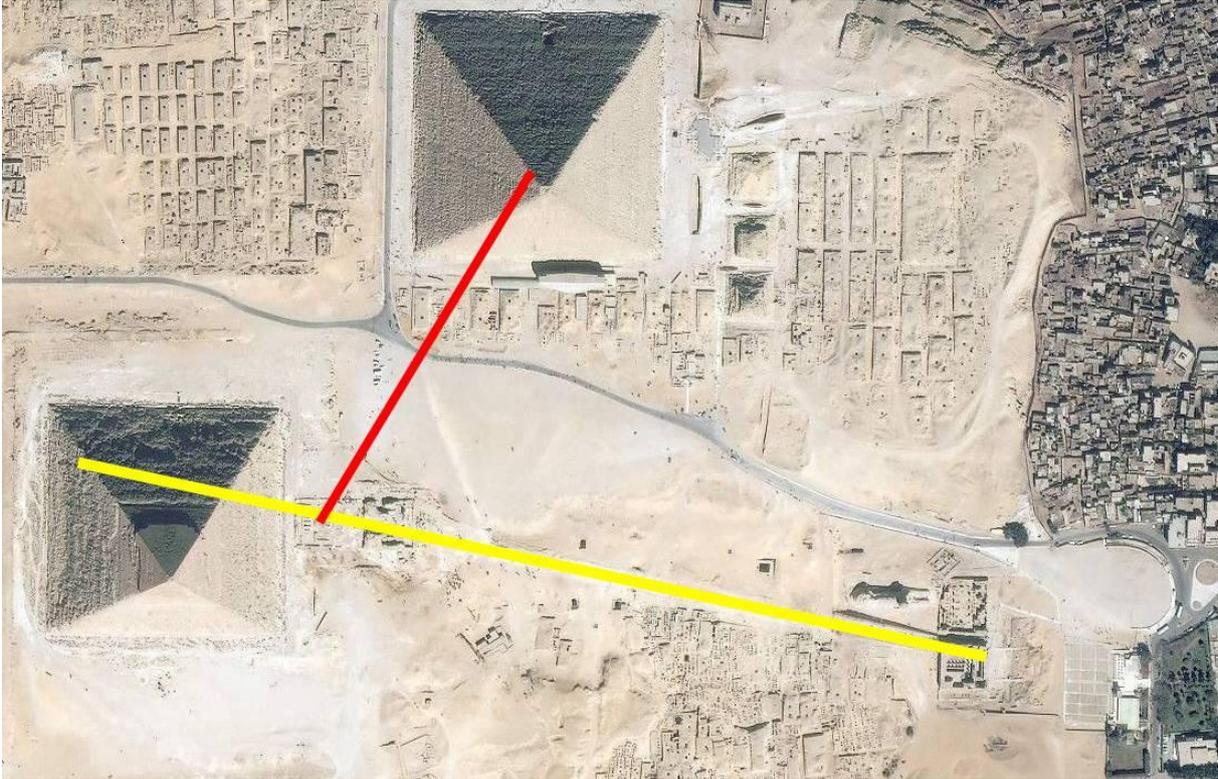
The trench must therefore have been located "under" the present pyramid of Khafre. Superimposed on the picture, the plan of the pyramid of Khafre and its internal structures.

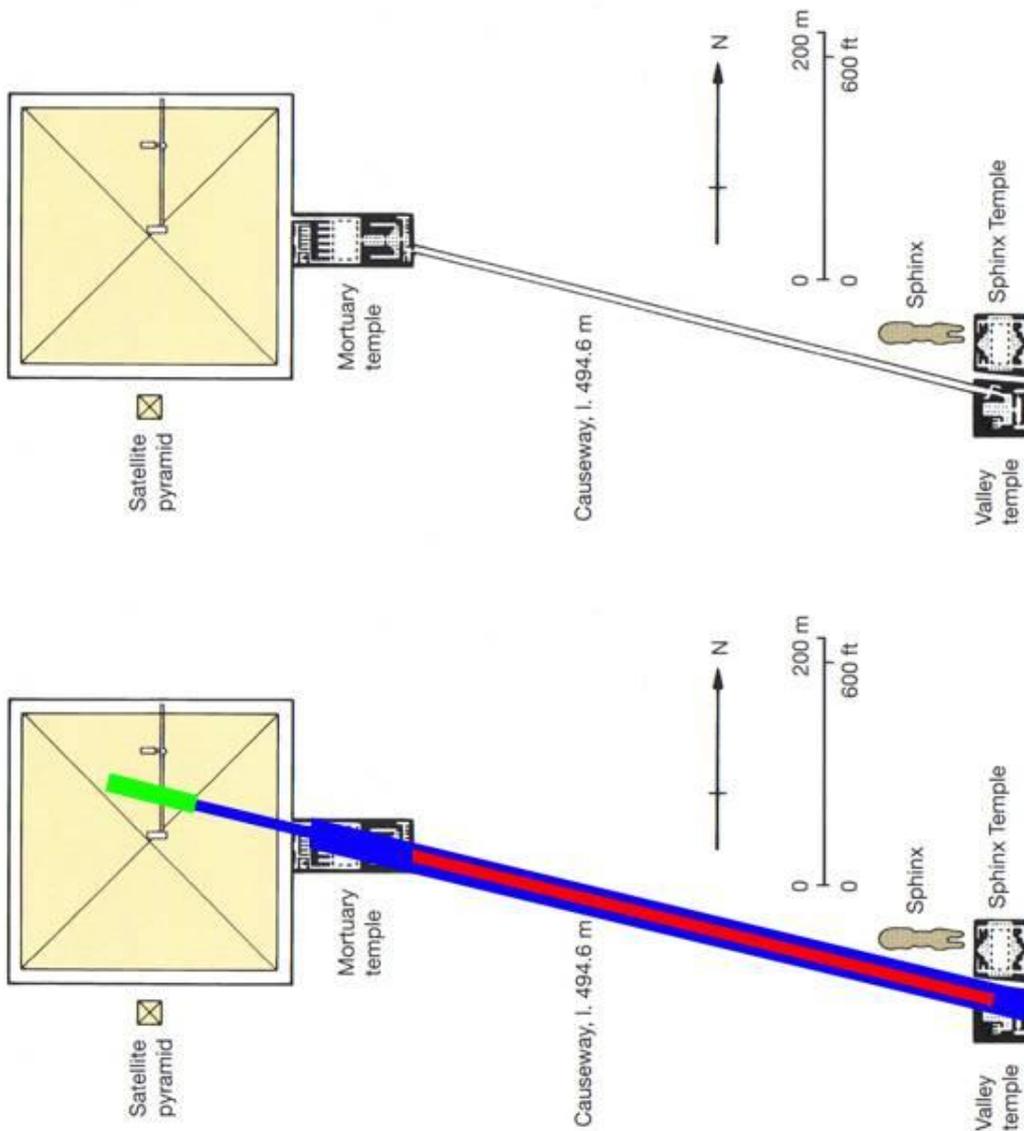
Wide blue: foundation of the causeway (ramp of Khufu)

Narrow blue: extrapolation of the foundation

Red: the Royal Causeway of Khafre.

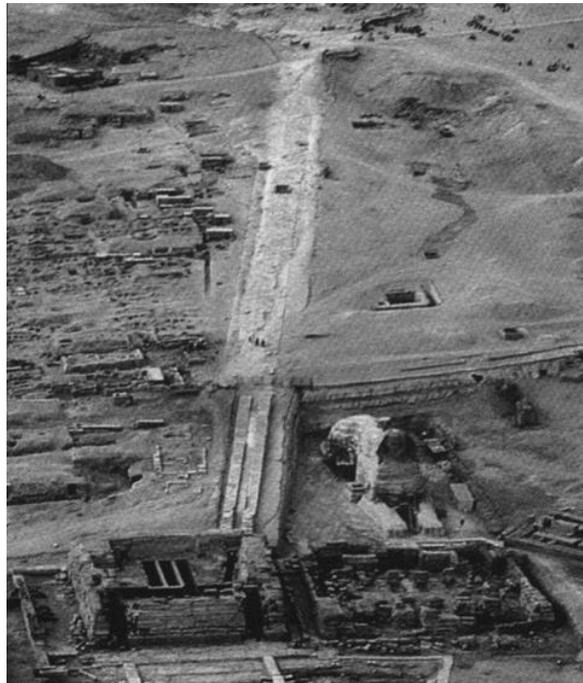
Comparison of the three Royal Causeways on the Giza Plateau.

The Causeway of Khafre has wide lateral foundations. Comparison with the foundations of the two other pyramids shows that the other two Royal Causeways were not constructed on foundations extending laterally beyond the edges of the causeways themselves. The walls rest directly on the ground. The Royal Causeway of Khafre was laid on a foundation that existed at the time of construction.

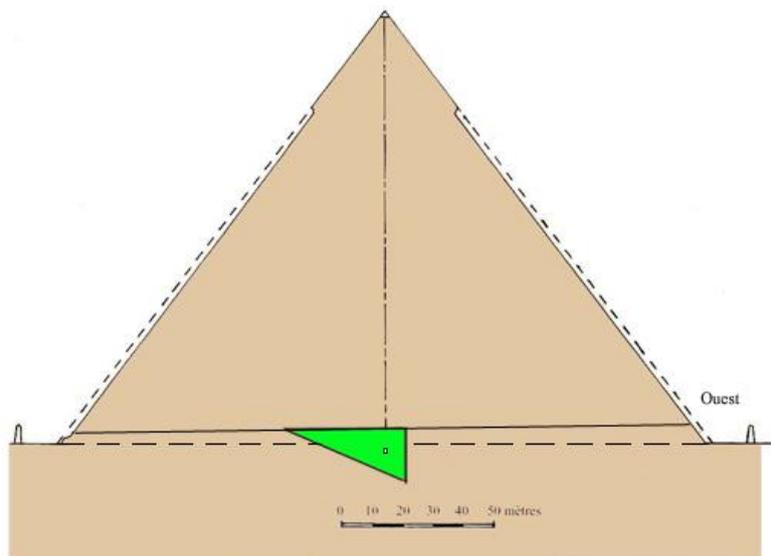
If the corridor had been positioned in the north-south axis, it would have crossed the trench where it was very deep, requiring a fairly large foundation block to be recreated, a “prop” about ten metres high, in order to find support on the rock.

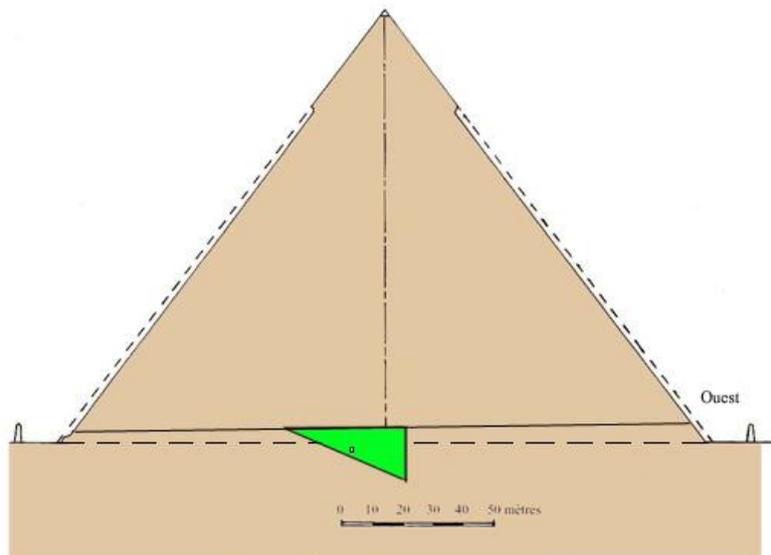
The designers considered it preferable to run the trench as close as possible to the bedrock in order to reduce the underpinning requirement as far as possible; to do this, they offset the corridor 23 cubits to the east. In addition, the trench certainly having been filled in quickly towards the end of the construction of the pyramid of Khufu, it was not necessary to completely excavate it if it was not in line with the future upper horizontal corridor.

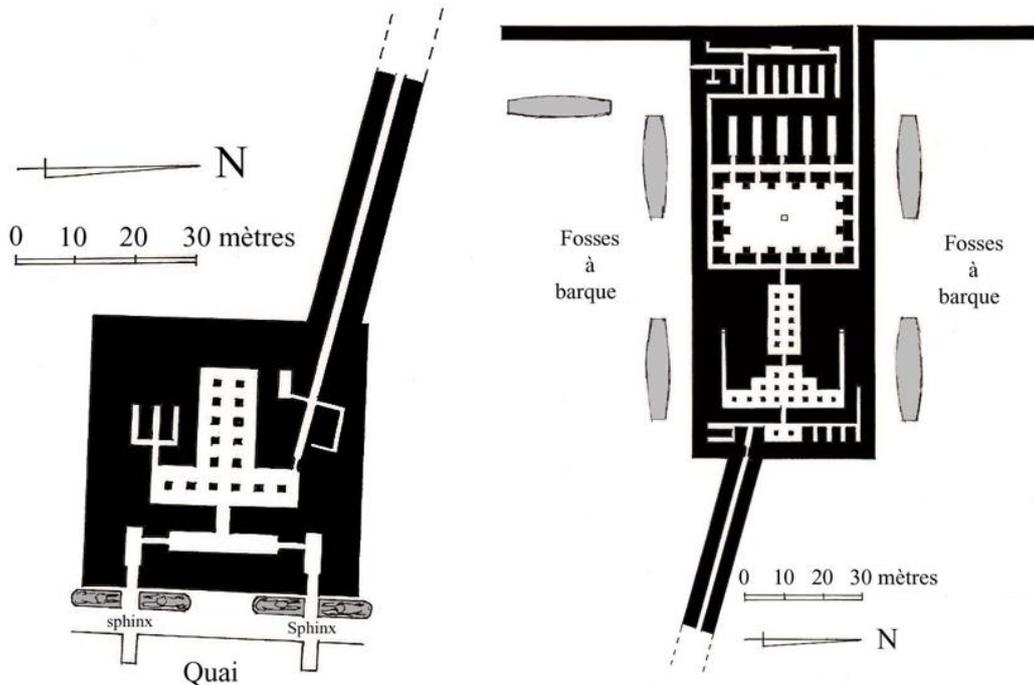
Entrance to the High Temple of Khufu: although the Royal Causeway is at an angle, it joins the High Temple on the (west-east) axis aligning it with the pyramid.

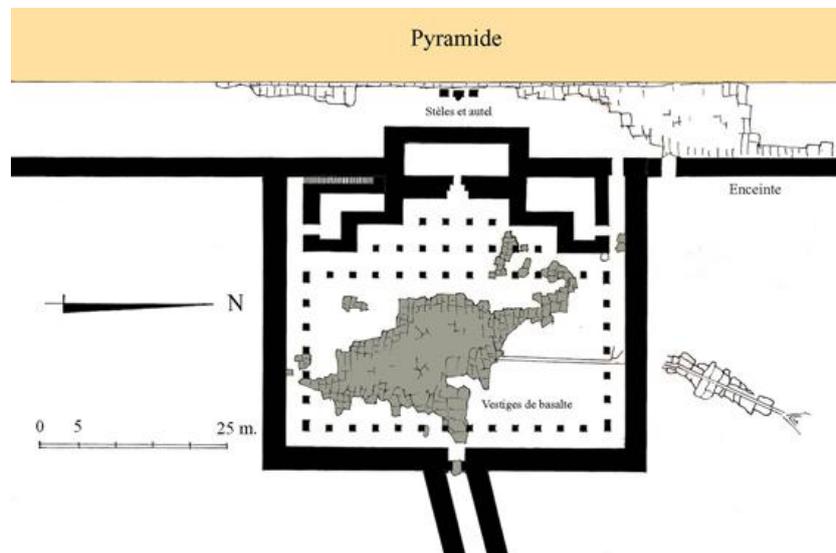
Entrance to the High Temple of Menkaure (or Mykerinos): the Royal Causeway is straight and enters the High Temple perpendicularly, in line with the (east-west) axis between it and the pyramid.

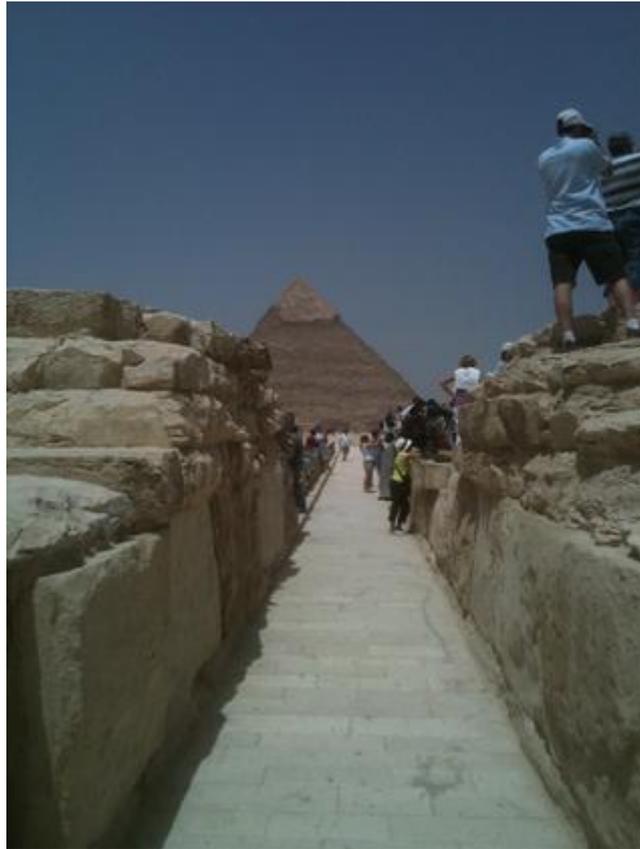
The Royal Causeway seen from the high exit of the Low Temple.

It is noteworthy that the axis of the paved passage points straight towards the central/northern zone of the pyramid. The passage is about 4 cubits wide, wall to wall, an identical width to the imprint of the paving on the Royal Causeway of Menkaure.

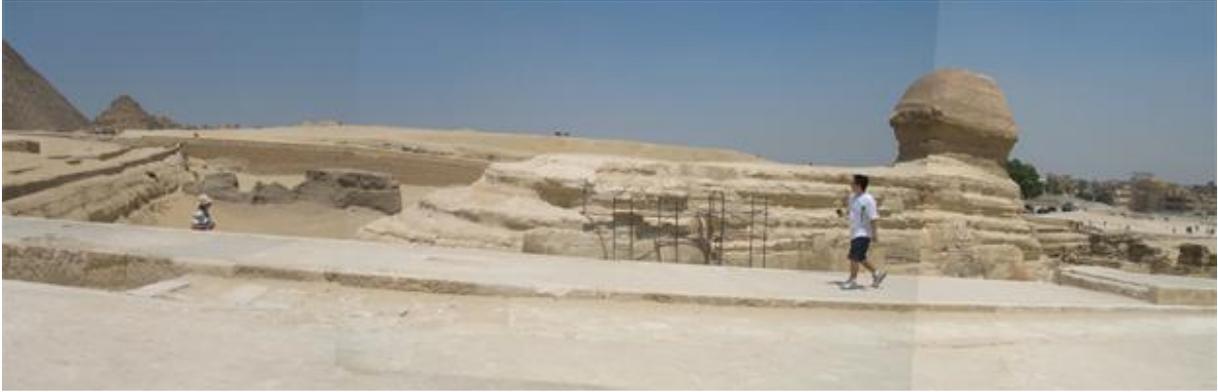
On the left, taken from the western edge of the Sphinx quarry, the view east down towards the departure of the Royal Causeway (a modern reconstruction) from the Low Temple. On the right, from the same position but facing west, view of the causeway towards the pyramid. Here, the floor of the causeway is cut directly into the bedrock, following the natural slope of the ground.

The measured width of the stonework in the left hand photograph is about 16 cubits, like the causeway of Menkaure, ten cubits more than the verges. In the photograph on the right, the causeway widens to a few tens of metres from this point.

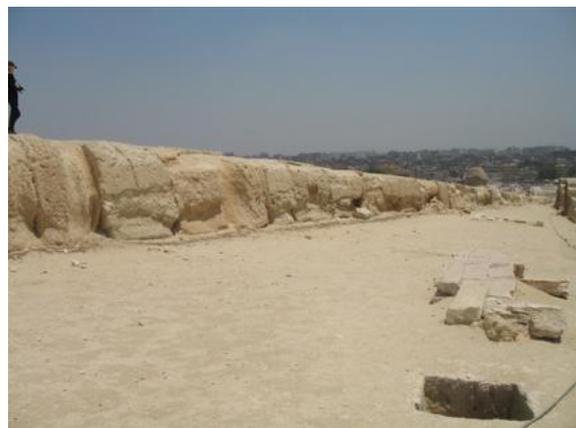
A single layer of blocks was sufficient to fill in this slight depression. Passers-by show the scale of the blocks. The bedrock was even excavated under the causeway afterwards.

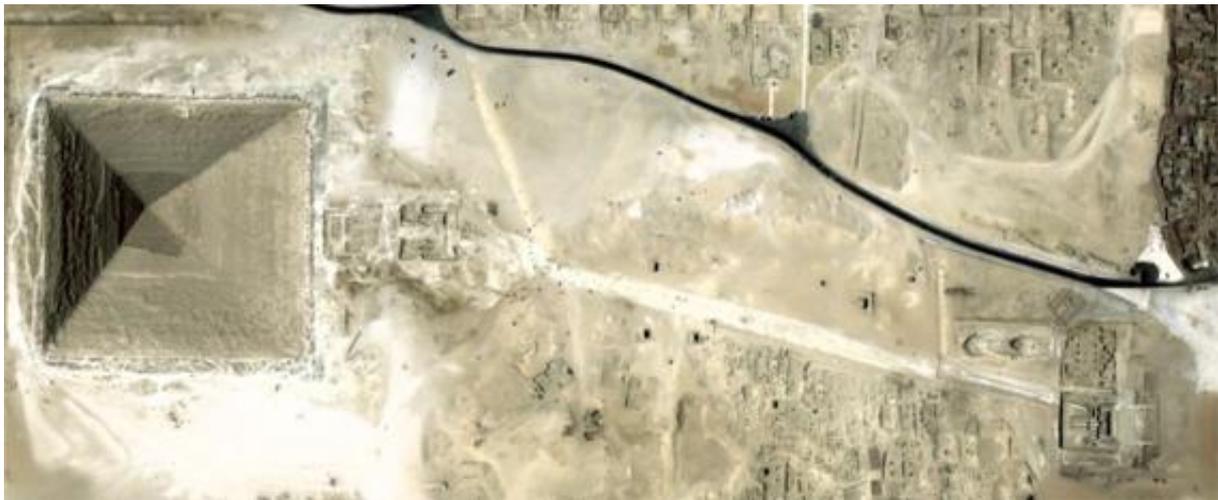
The High Temple was built on a levelled natural promontory.

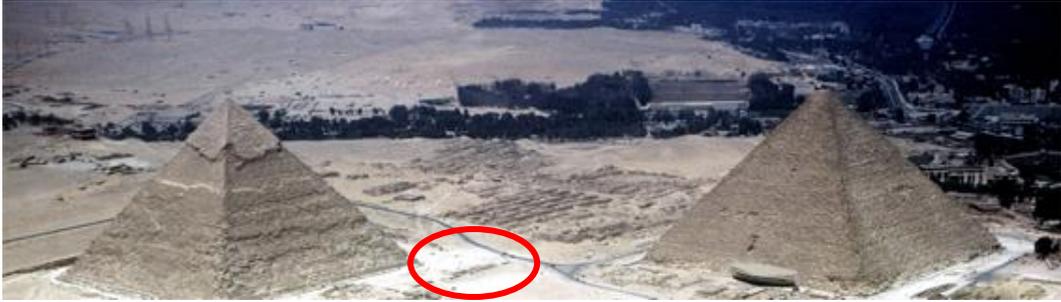
This aerial photograph shows this outcrop in the direction of the pyramid of Khufu quite clearly.

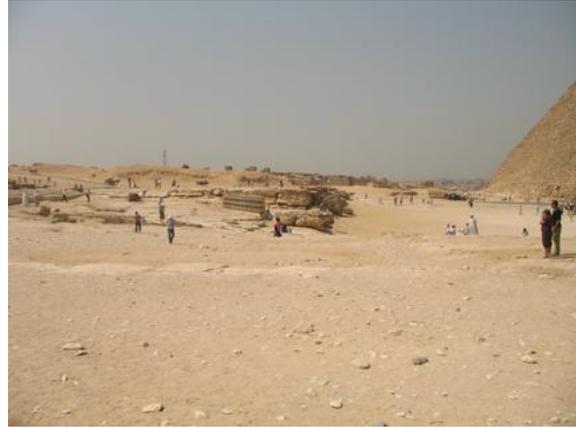
On the left, the platform seen coming from the pyramid of Khufu and on the right view from the northern side of the High Temple of Khafre. This north-east area is to be compared with the south-eastern area of the base of the pyramid of Khafre. In this part, and only a few metres from the first course, the paving sets out with a gentle slope to adopt the natural slope of the plateau towards both the south and the east; the finish is perfect.

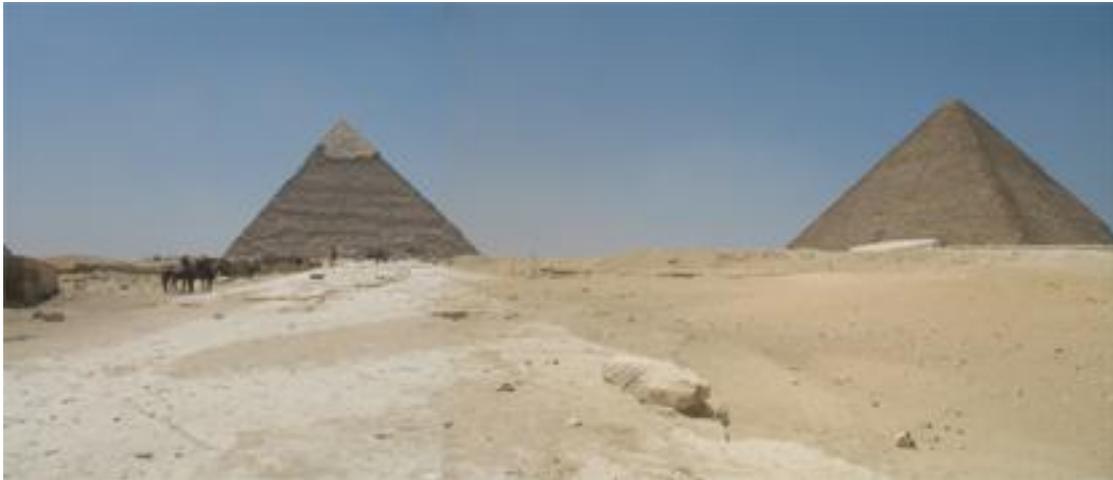
Current state of the Royal Causeway of Khafre with the pyramid of Khufu on the right.

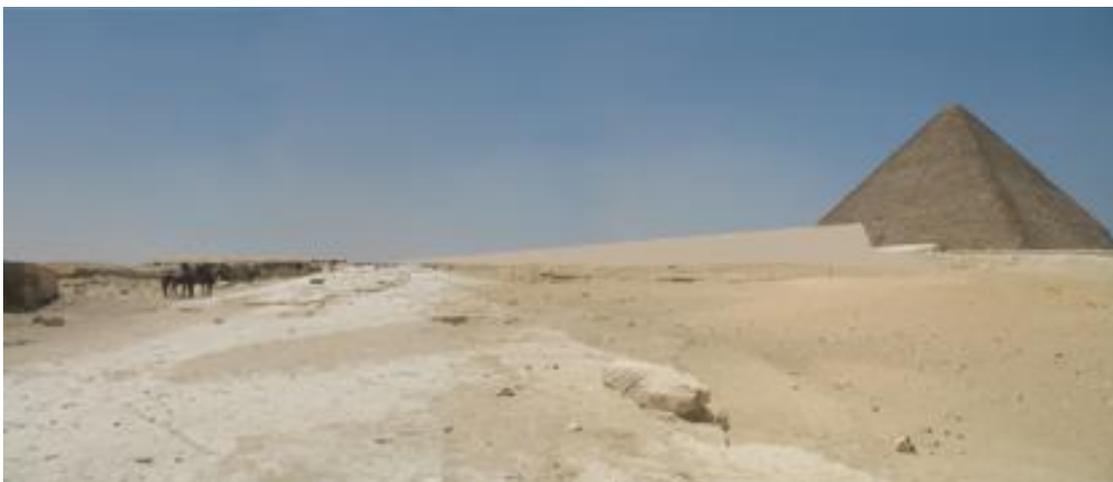
The original ramp linking the port to the base of the exterior ramp of the construction site for the pyramid of Khufu; forming an angle of  $80^\circ$ , this latter ramp (shown in beige at the centre of the photograph) continues on from the first ramp with a comparable slope. The total length of the two ramps is about 970 m and they rise 83 m between the level of the port and the level of the base of the King's Chamber, an average slope of 8.55%.

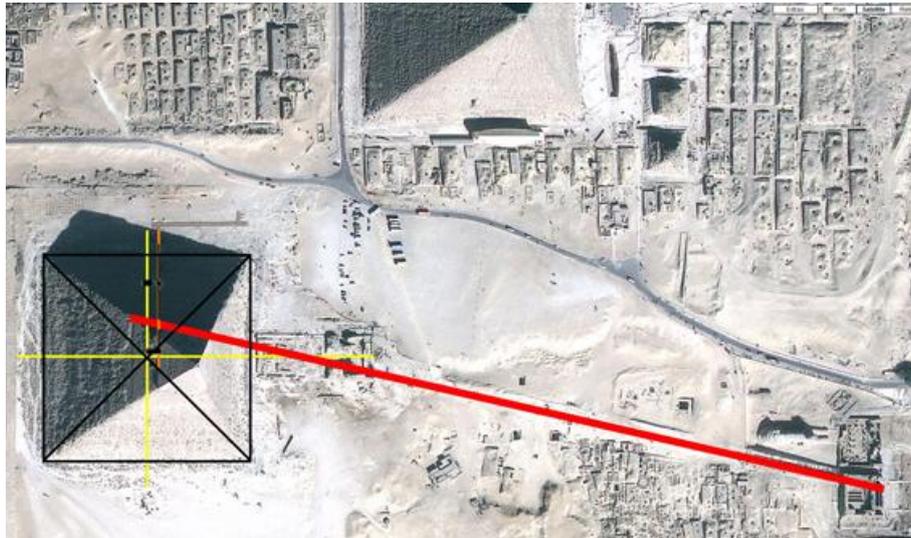
The axis of the ramp under the Royal Causeway of Khafre intersects the upper horizontal corridor of the pyramid of Khafre at a little less than one third of the distance, measured from the east-west axis, between this axis and the northern base.

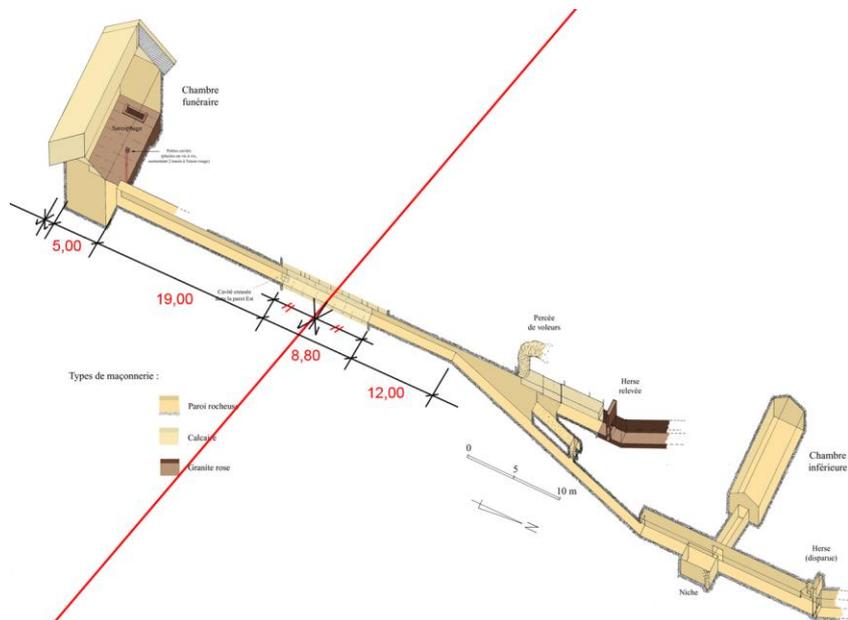
Measurements taken inside the pyramid show that a section of the upper horizontal corridor was stone-built, floor, walls and ceiling, over a length of 8.80 m (about 17 cubits), the axis of this stone-built part being located thirty metres north of the east-west axis of the pyramid, aligned with the extrapolation of the ramp under the causeway (red line). This section, which was stone-built in a trench at least ten metres deep, is in exactly the position assumed in the study. The stone-built length is entirely compatible with an original trench a dozen cubits wide enabling construction of a counterweight slideway comparable to the Great Gallery of Khufu; the extra cubits, distributed equally on both sides, would correspond to the lateral undermining trenches excavated in order to anchor the stone-built corridor into the bedrock, both to avoid vertical shear and to compensate for the angle of the trench relative to the corridor.

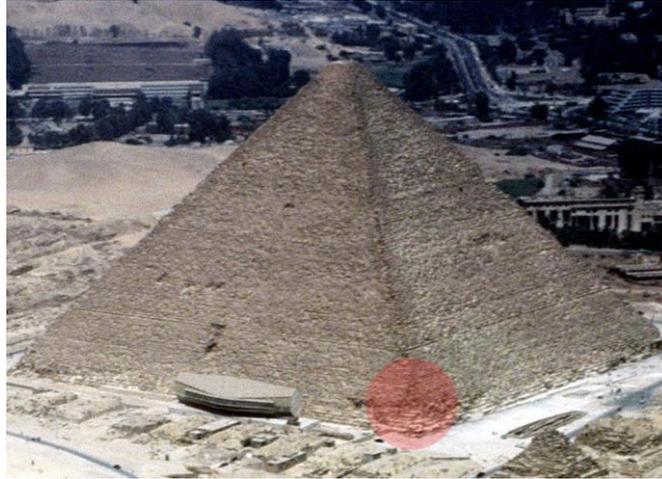
According to the theory, the assumed entrance to the interior ramp is located in the south-east corner (red area).

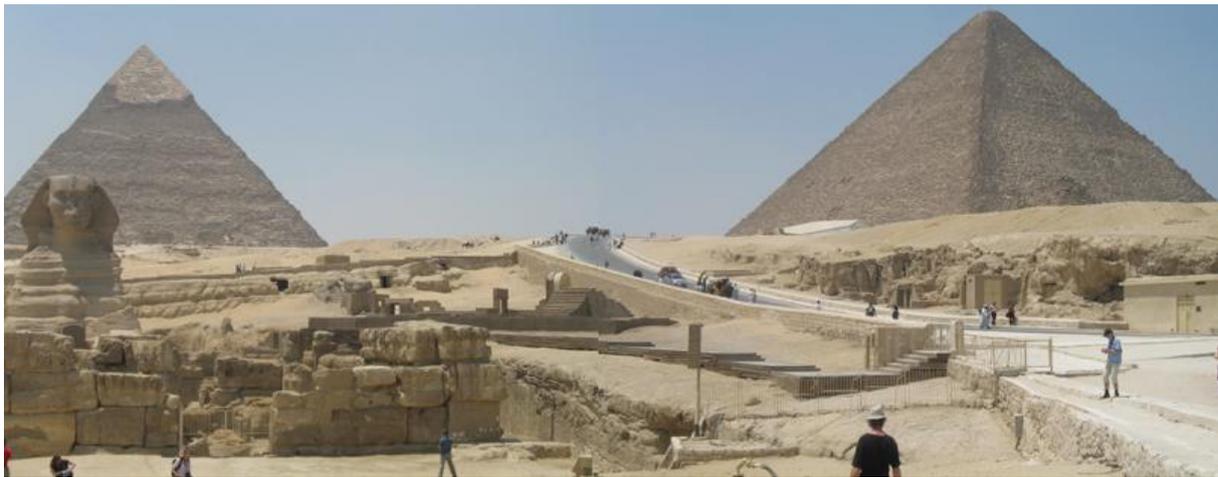
Panoramic view from the esplanade in front of the Temple of the Sphinx.  
 In the centre of the photograph, it will be noticed that the remaining bedrock allows us to guess the slope of an old ramp used as the foundation for the modern road.  
 To the left and behind the Sphinx, the strata of the quarry clearly show the incline of the northern flank of the plateau to the south of the pyramid of Khufu.  
 On the right, the northern flank of the Sphinx quarry.

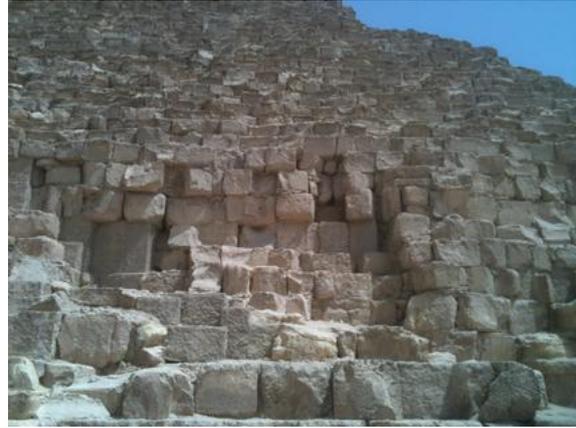
The positions of the blocks are very curious; some parts have been sealed by rubble and cement mortar, while on each side of this area the stone-work is matched and regular. We also found recent stone-work that came to the fore in places.

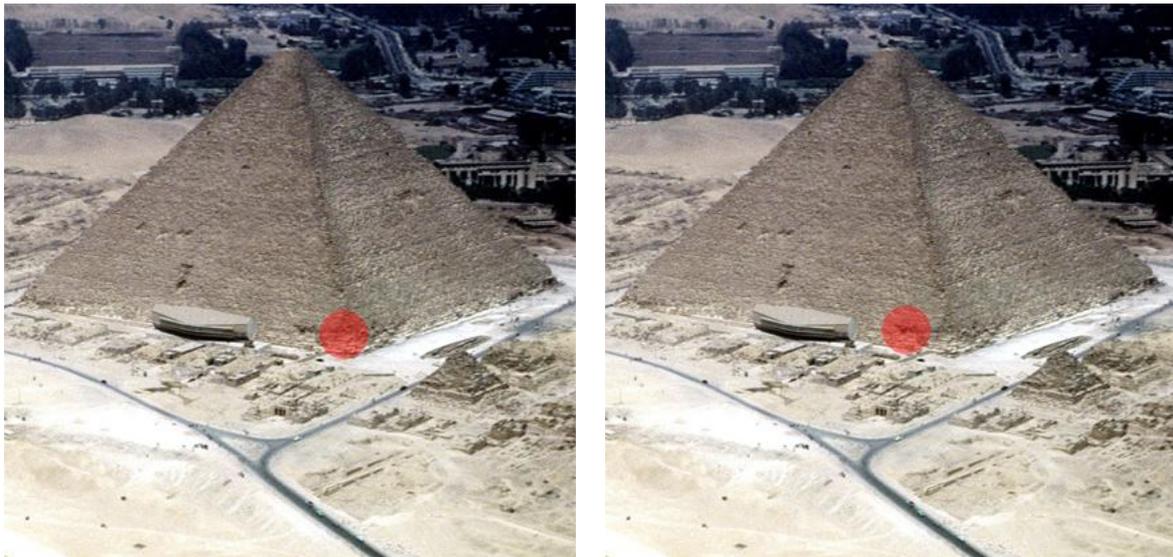
The entrance to the interior ramp is not at the corner as indicated on the left-hand photograph, but about 25 m to the west of the corner as shown on the right-hand photograph.

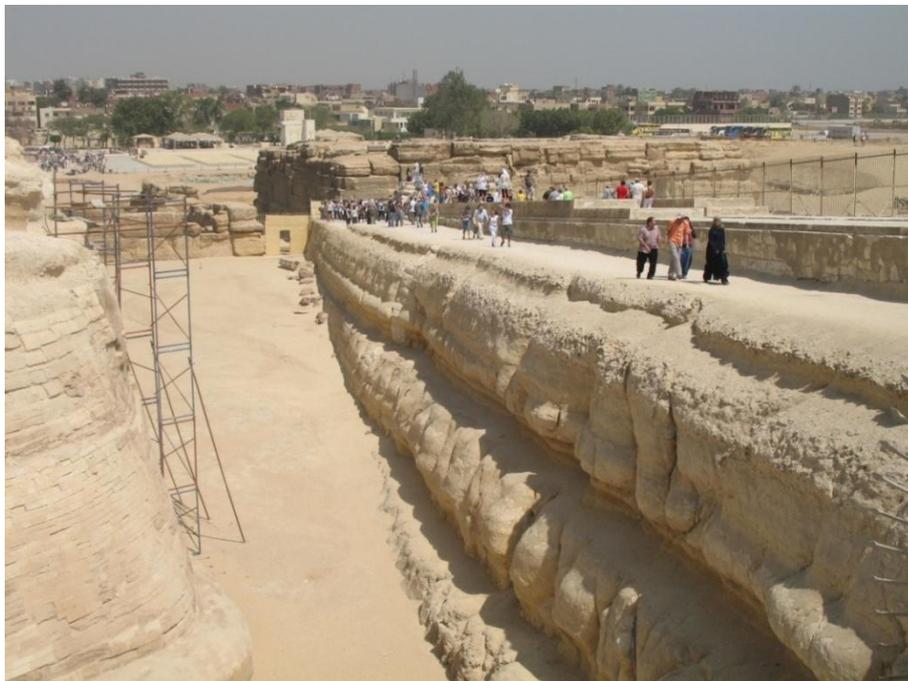
The space between the pit and the masonry of the monumental roadway is heavily eroded at the top; there is also a marked sense of run-off erosion at the bottom of the pit.

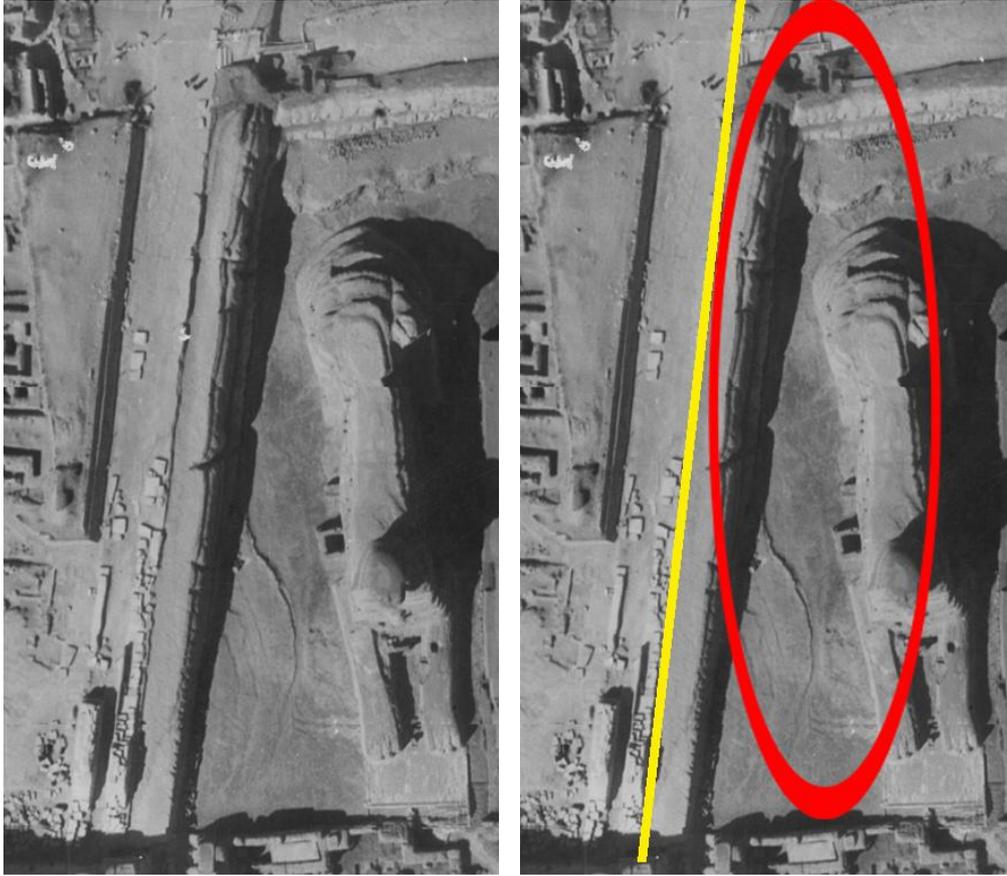
Finally, in the photo below, we can see that there is no trace of marked erosion due to runoff in the bottom of the northern part of the pit, to the right of the Sphinx, confirming a cause-and-effect relationship in the southern part (left).

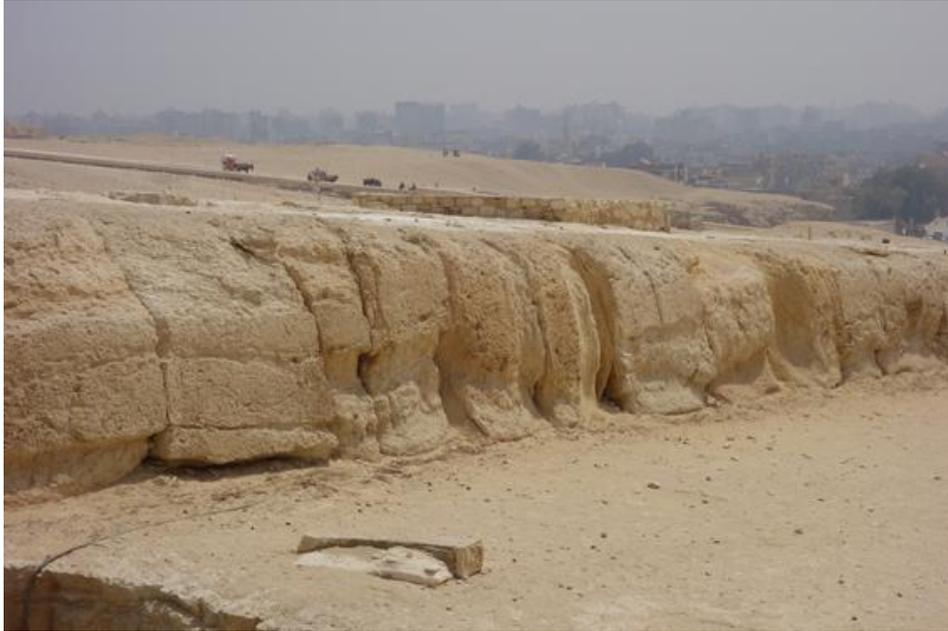
Erosion, represented by the yellow line on the 3D image, on the north wall of the low quarry along the south side of the monumental causeway.

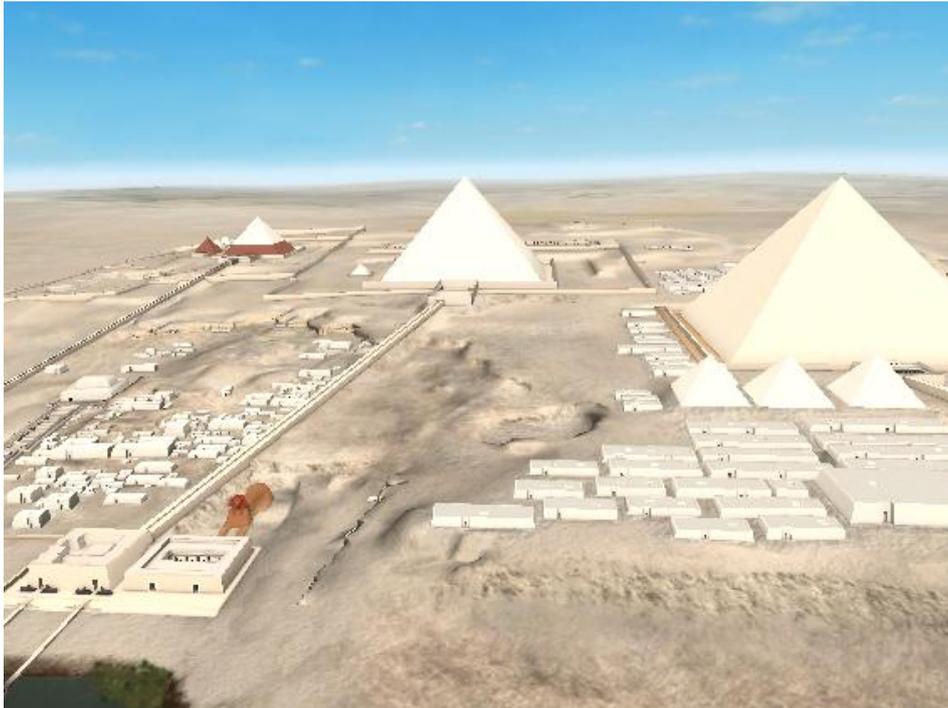
This 3D reconstruction of the Giza Plateau shows the three completed pyramids and the quarries that were used to build them, as well as an imposing masonry barrier in the middle of the quarries that completely divides the topography of the site into two parts: the Monumental Causeway of Khephren.

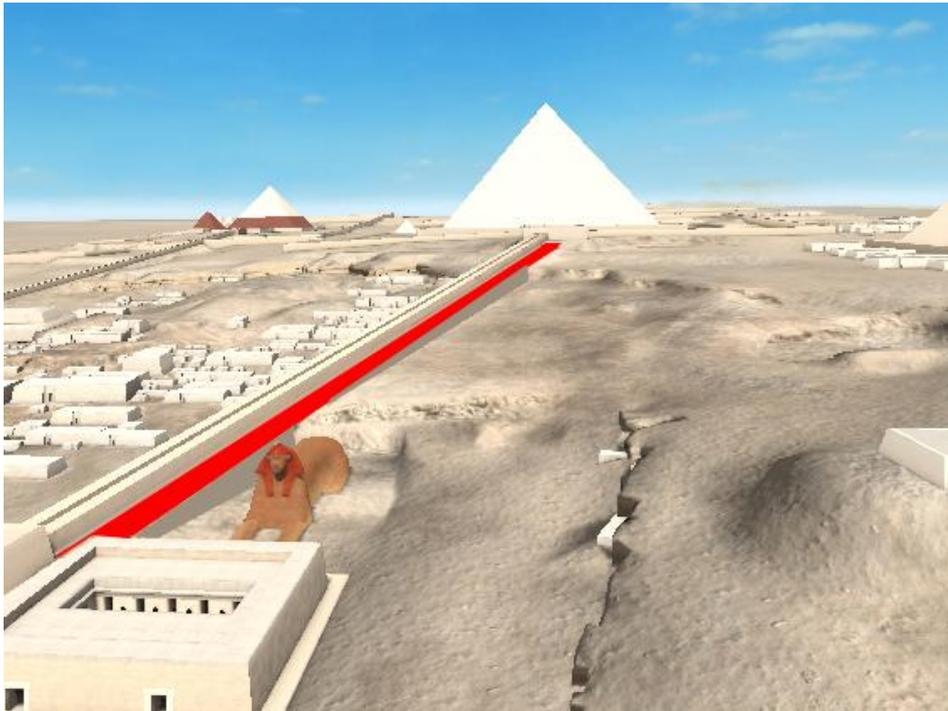
The red-highlighted "gutter" running alongside the Chaussée Monumentale.
