Egypt Fourth Dynasty

# CRITICAL ANALYSIS OF THE GIZA PLATEAU

Study carried out by Jean-Pierre Houdin

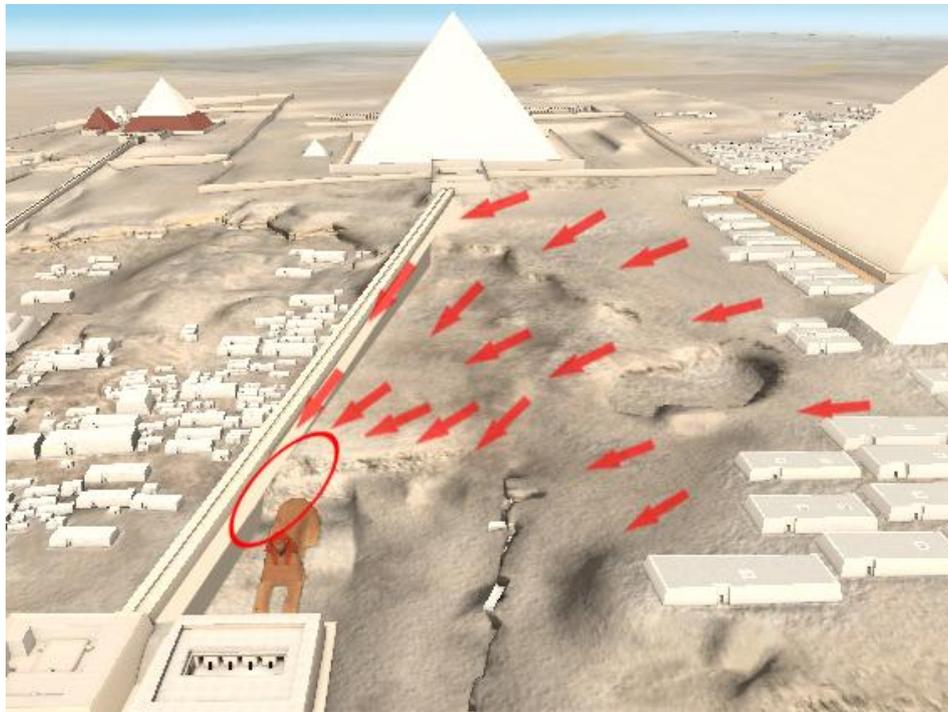
Despite the fact that the quarries to the north of Khephren's Monumental Causeway have filled in over time, it's easy to see from this panoramic photo that all run-off water converged on the area circled in the 3D image above and on this one.

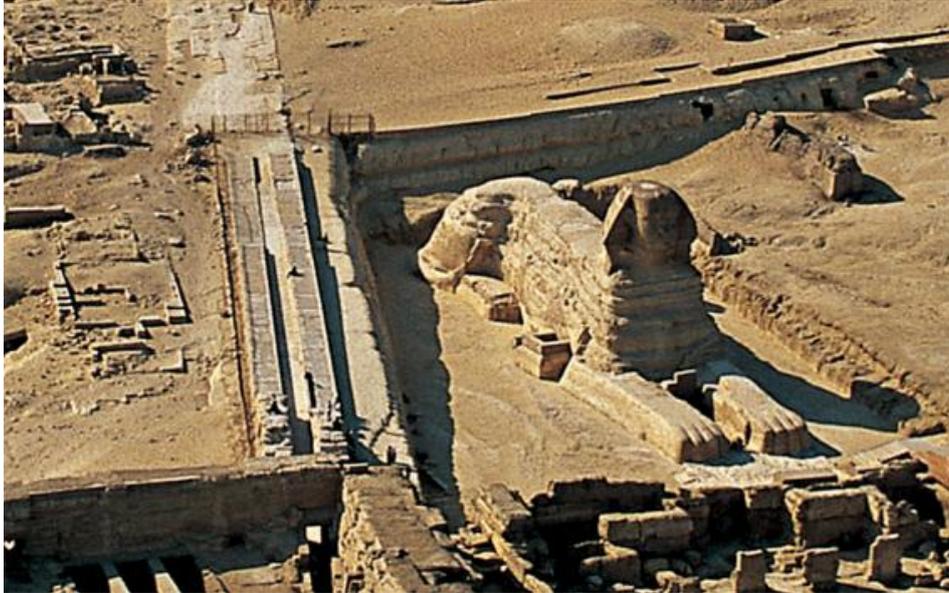
Khephren's Monumental Causeway channeled runoff into the Sphinx pit.

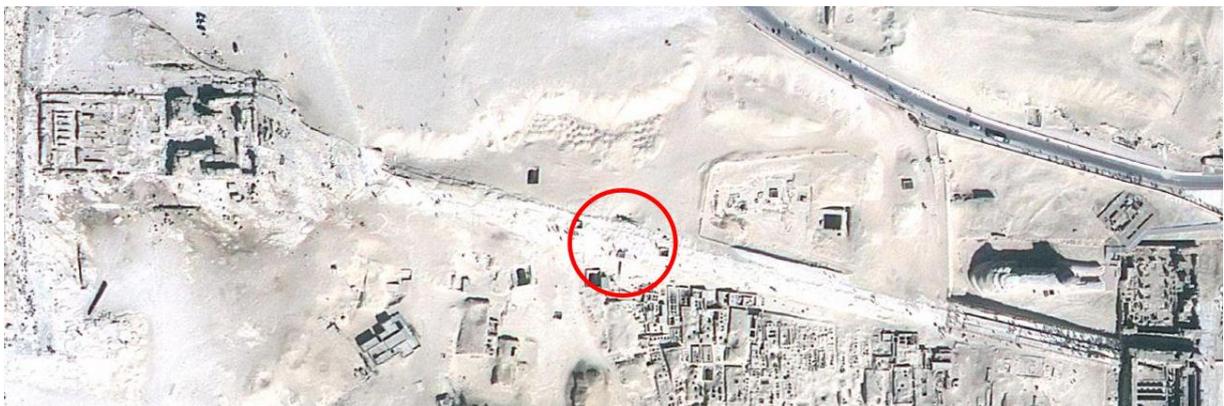
The type of piercing is rather curious, reminiscent of a concrete nozzle found under roads to let rainwater through.

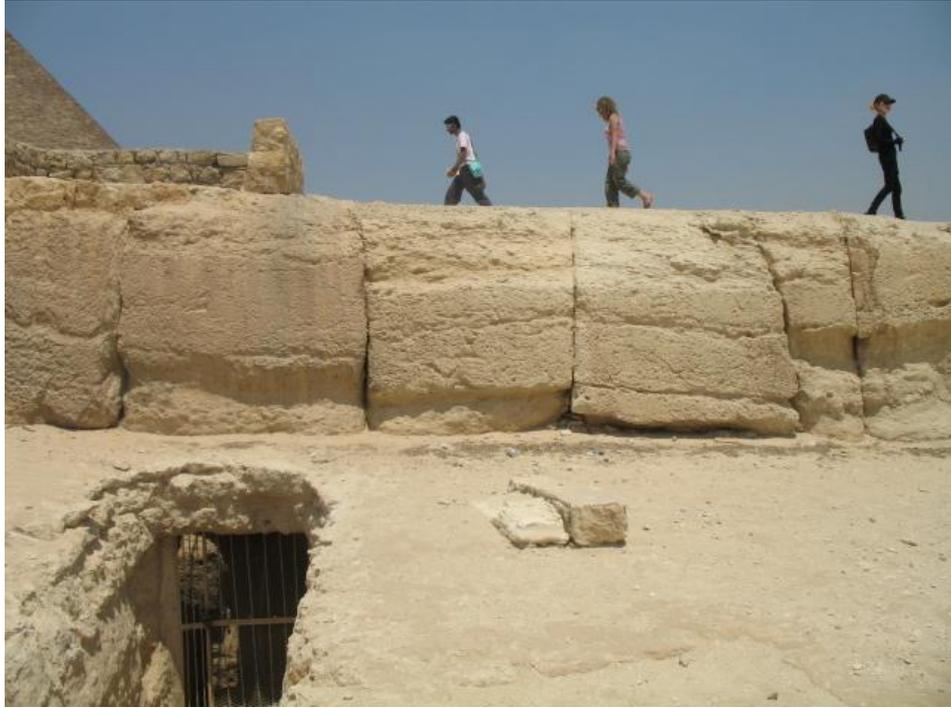
View of the tunnel entrance on the south side of the Chaussée Monumentale.

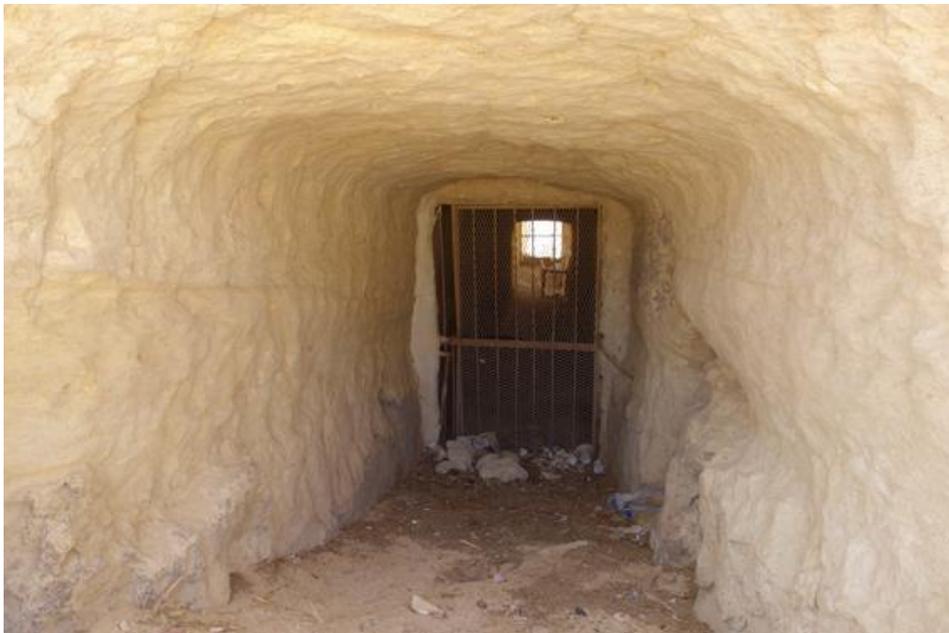
View of the tunnel entrance on the north side of the Chaussée Monumentale. The Chaussée Monumentale has been partly filled with sand, as has the quarry that runs alongside it. The bottom of the quarry and that of the tunnel must both have been at the same level.

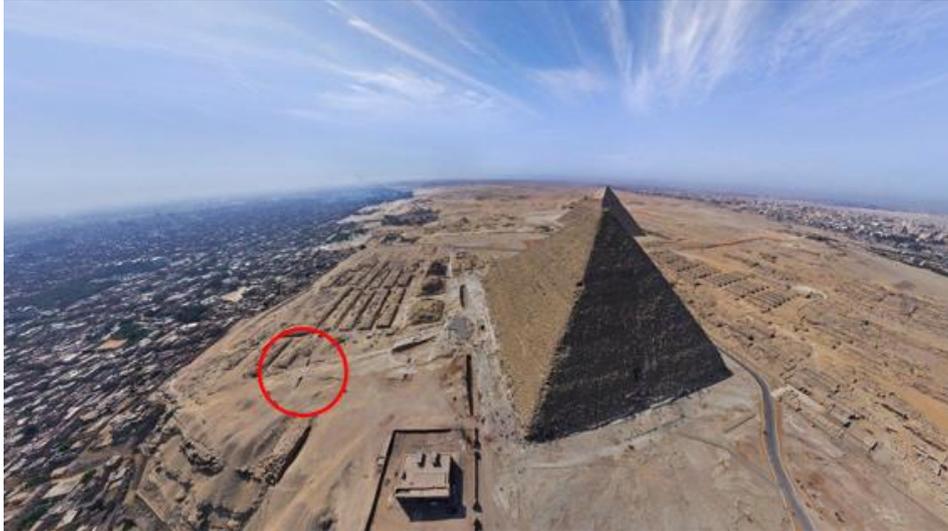
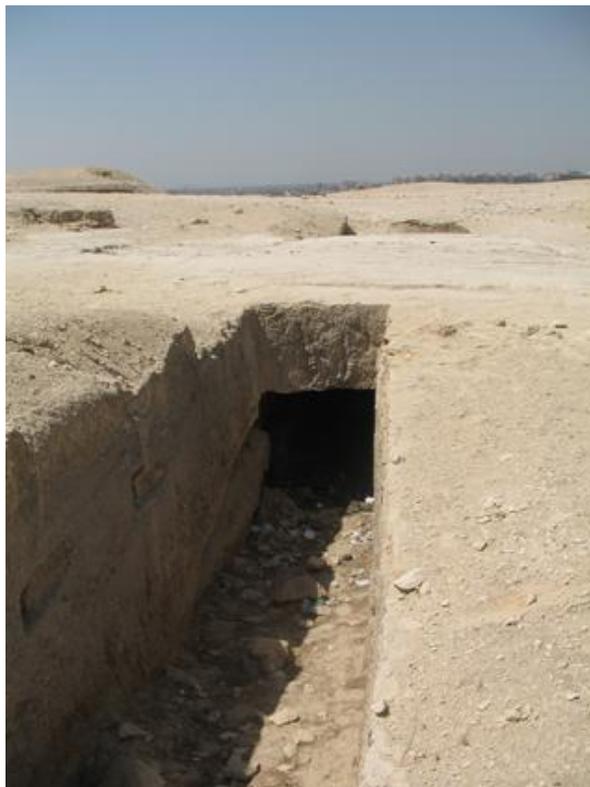
It seems clear that this relatively shallow tunnel was not intended as a passageway for humans, but more likely to evacuate run-off water.

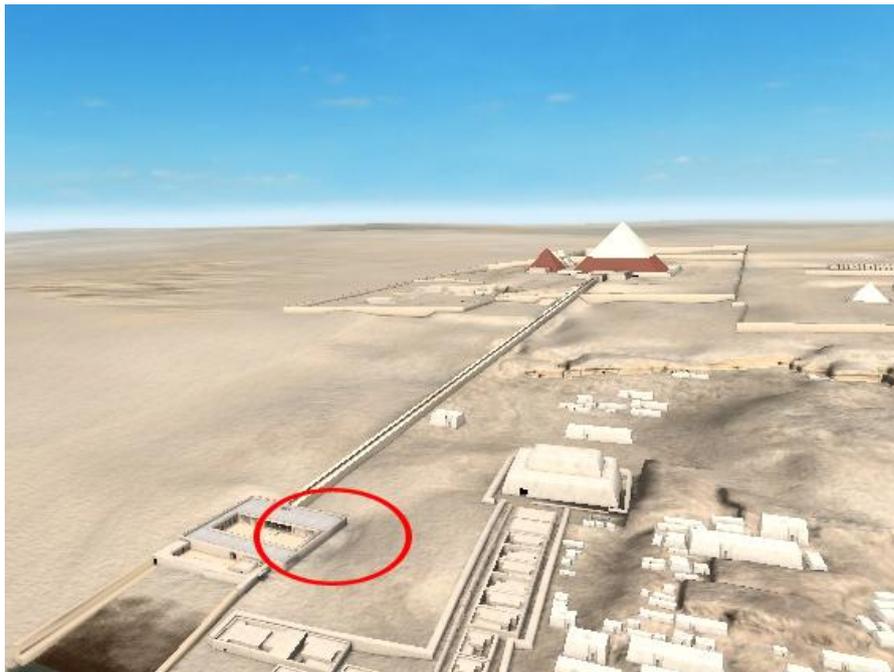
As you can see, the Mykerinos Monumental Causeway once again cuts the Giza Plateau in two. It would seem, then, that the problem of rainwater run-off was a recurring one, due to the impassable barriers created by the Monumental Causeways. You can't think of everything...
